## Morphometric Characterization and Agricultural Implications of Gully Erosion in Gashala Area, Hong LGA, Adamawa State, Nigeria.

### Abstract

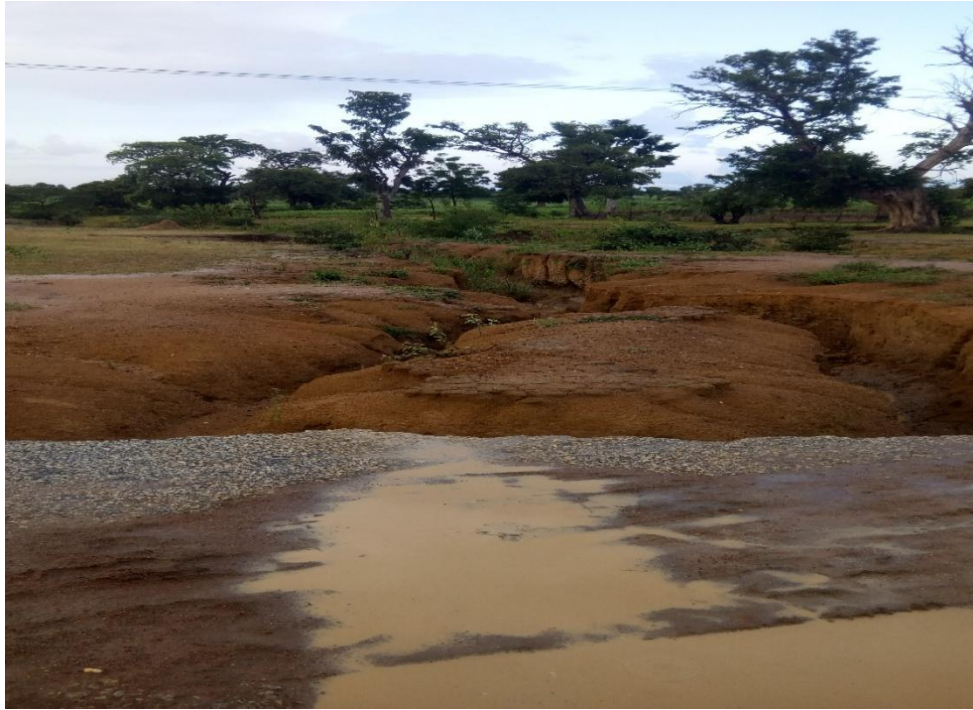
**Plate 1:** Typical farmland been abandoned as a result of gully erosion at Mugau

Gully erosion had caused considerable damage to infrastructure like roads, residential buildings, schools and farmlands in Gashala area, and it's still posing serious challenge to arable lands around the region (Plates 1, 2 and

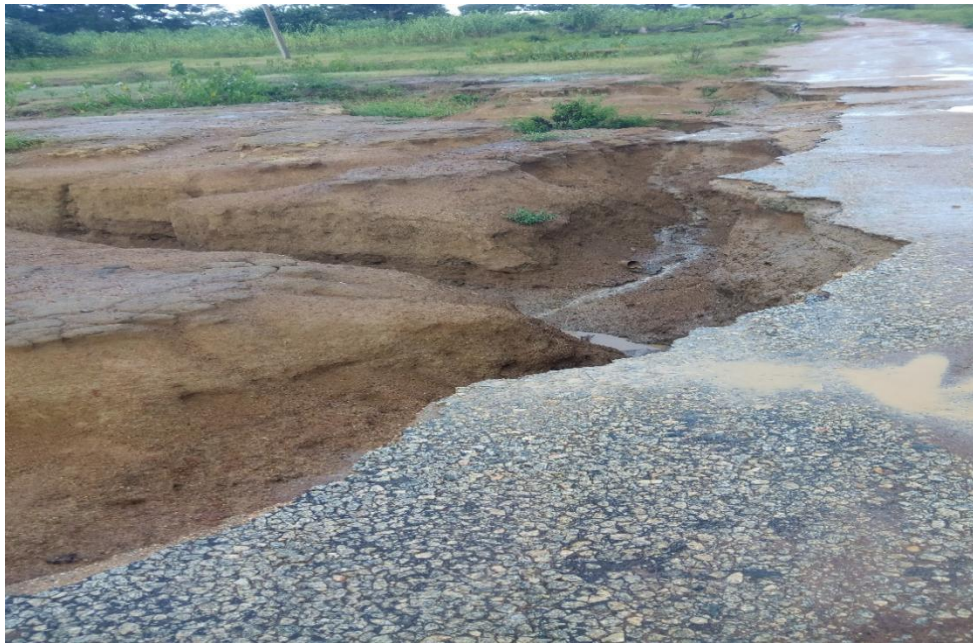
**Plate 2:** Road nearly cut off by a gully erosion at Mugau 2

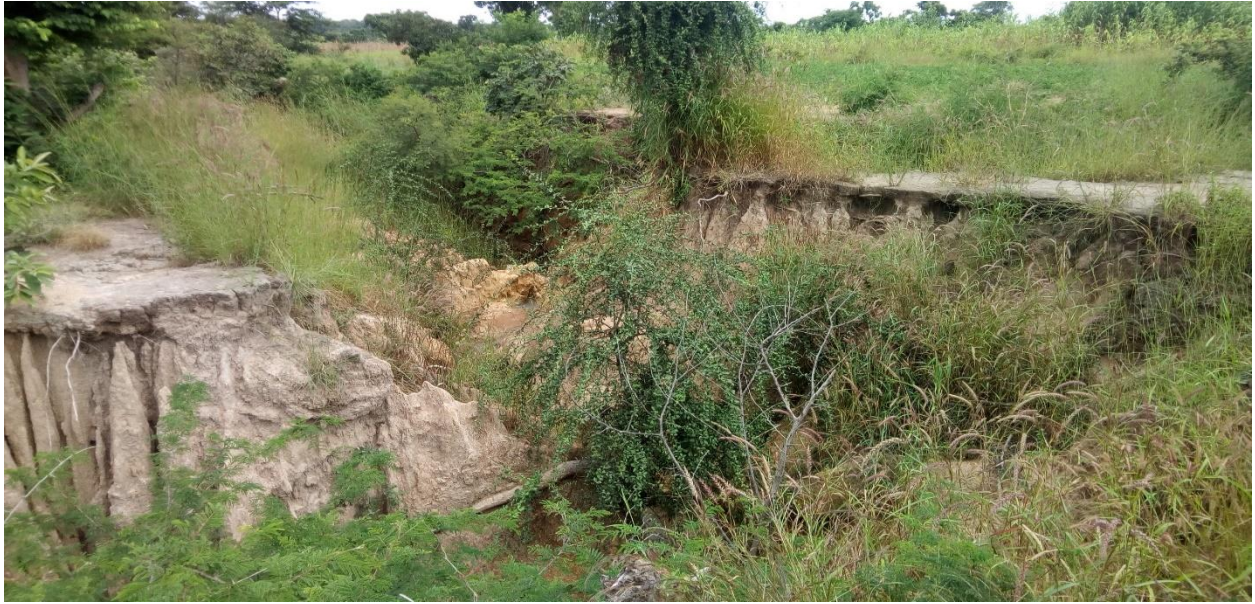
**Plate 3:** Another scenario of farmland abandoned as a result of gully erosion at Contarabi 3

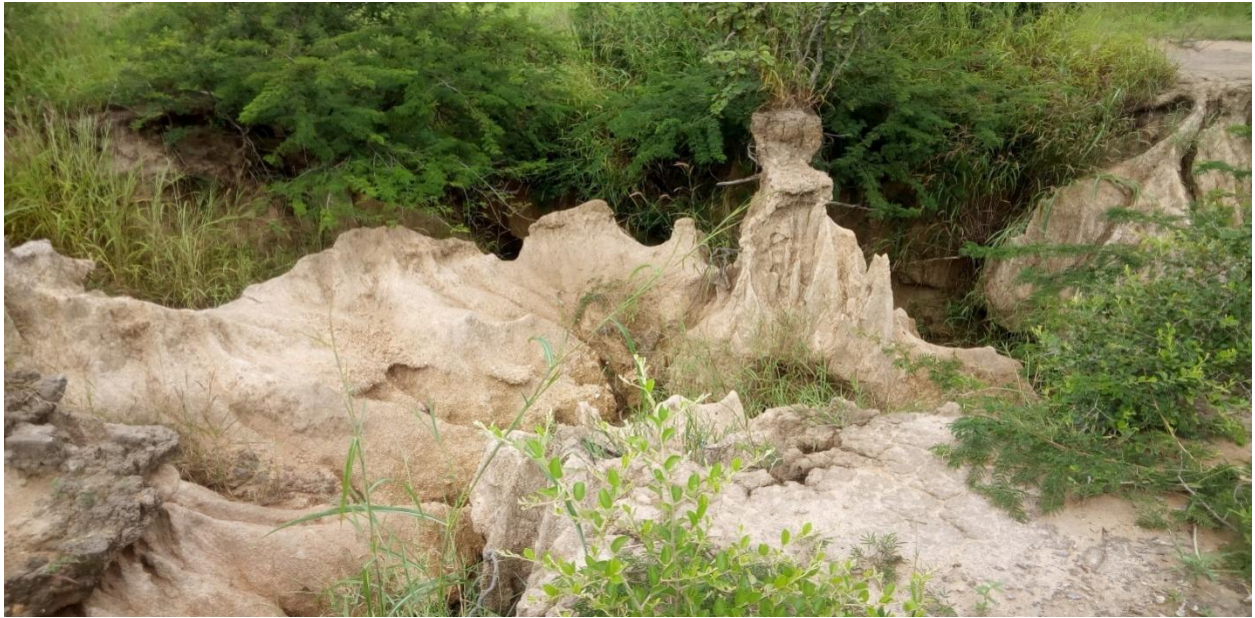
**Plate 4:** Gully erosion at early stage of development at Contarabi 1

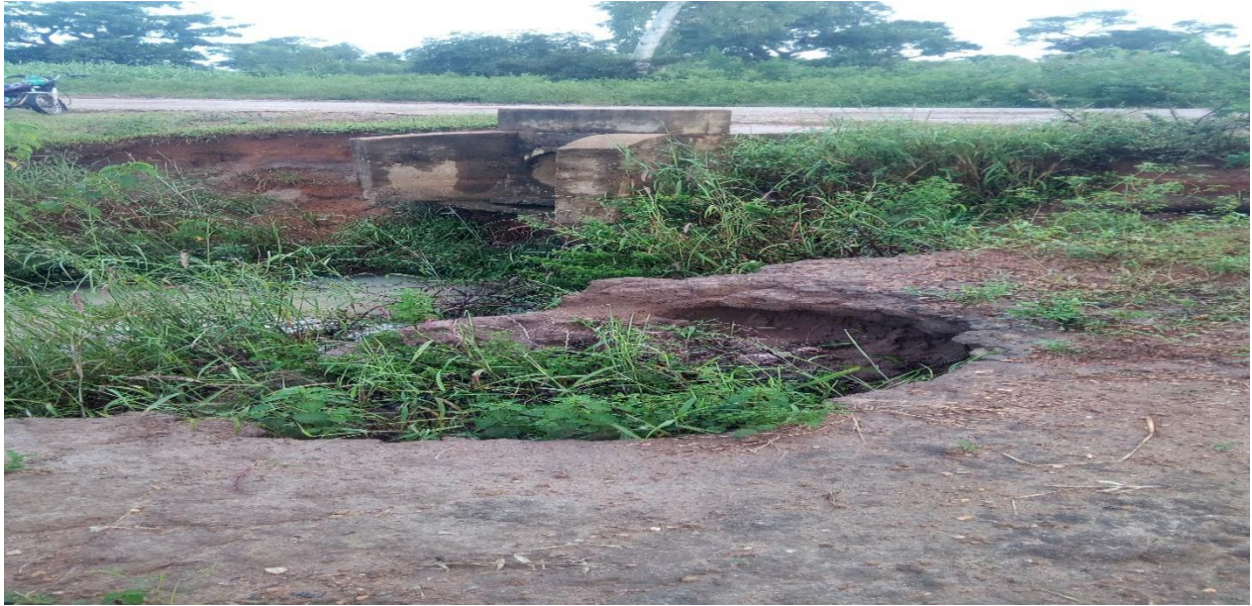
**Plate 5:** A typical example of gully hazard where a bridge is about to collapse at Mugau 2

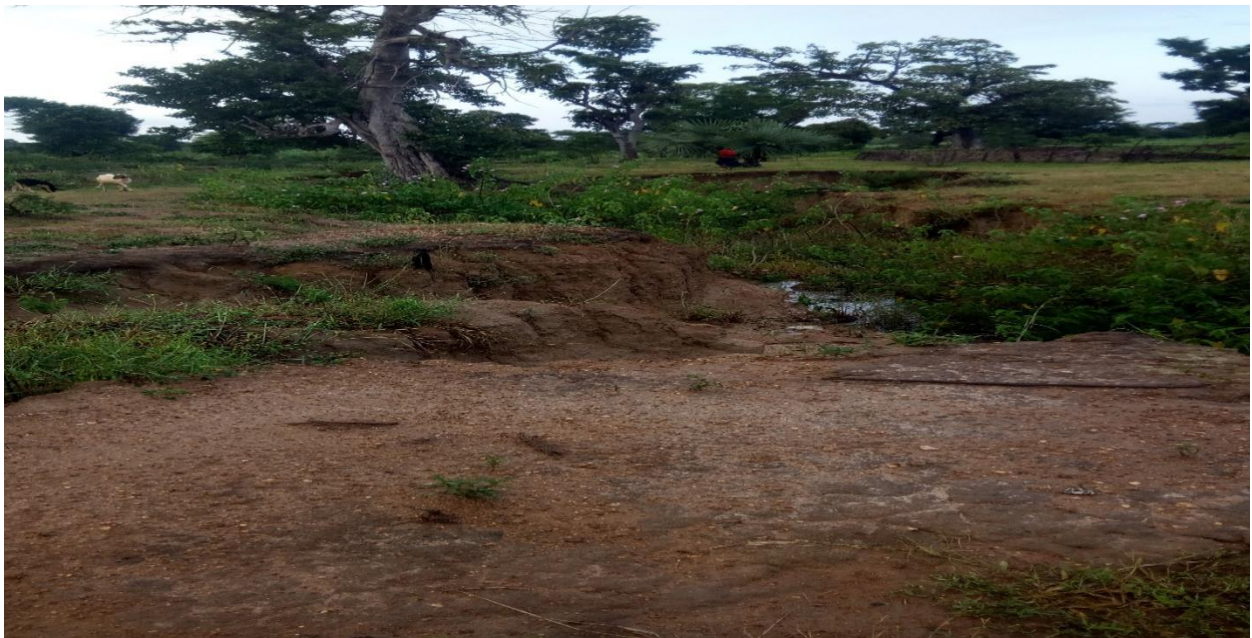
**Plate 6:** A farmland left uncultivated due to gully erosion menace; this is also a grazing area. Naiwa

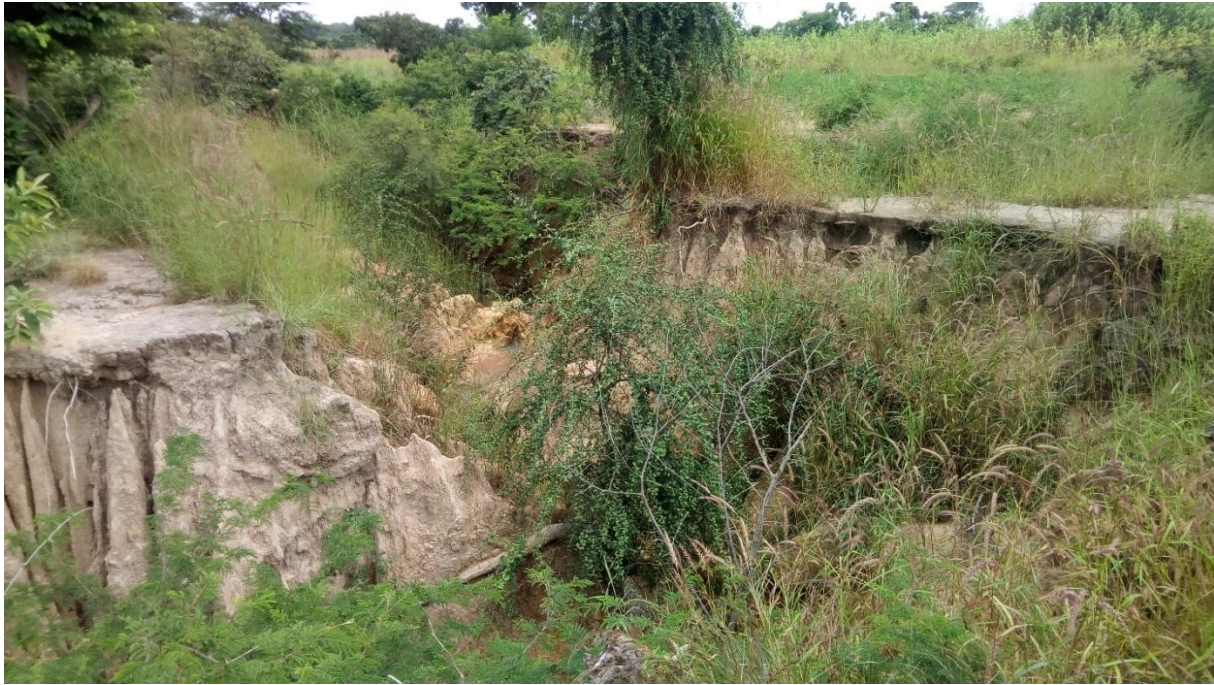
**Plate 7:** A typical example of a deep gully  $>200\text{cm}^3$  that made a farmland unproductive at Contarabi

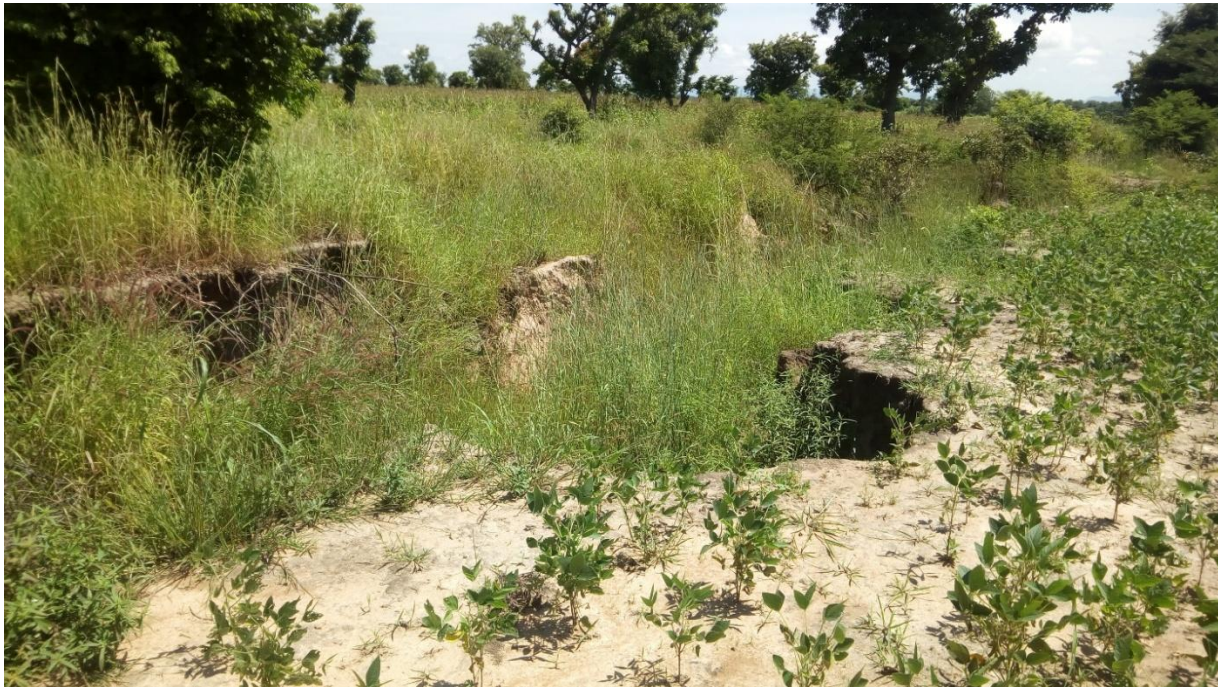
**Plate 8:** A gully erosion site that can no longer be used, as can be seen of cowpea been destroyed at Contarabi 3.
